NASA TM X-64754

VAMISTOR RESISTOR INVESTIGATION

Quality and Reliability Assurance Laboratory

May 1, 1973

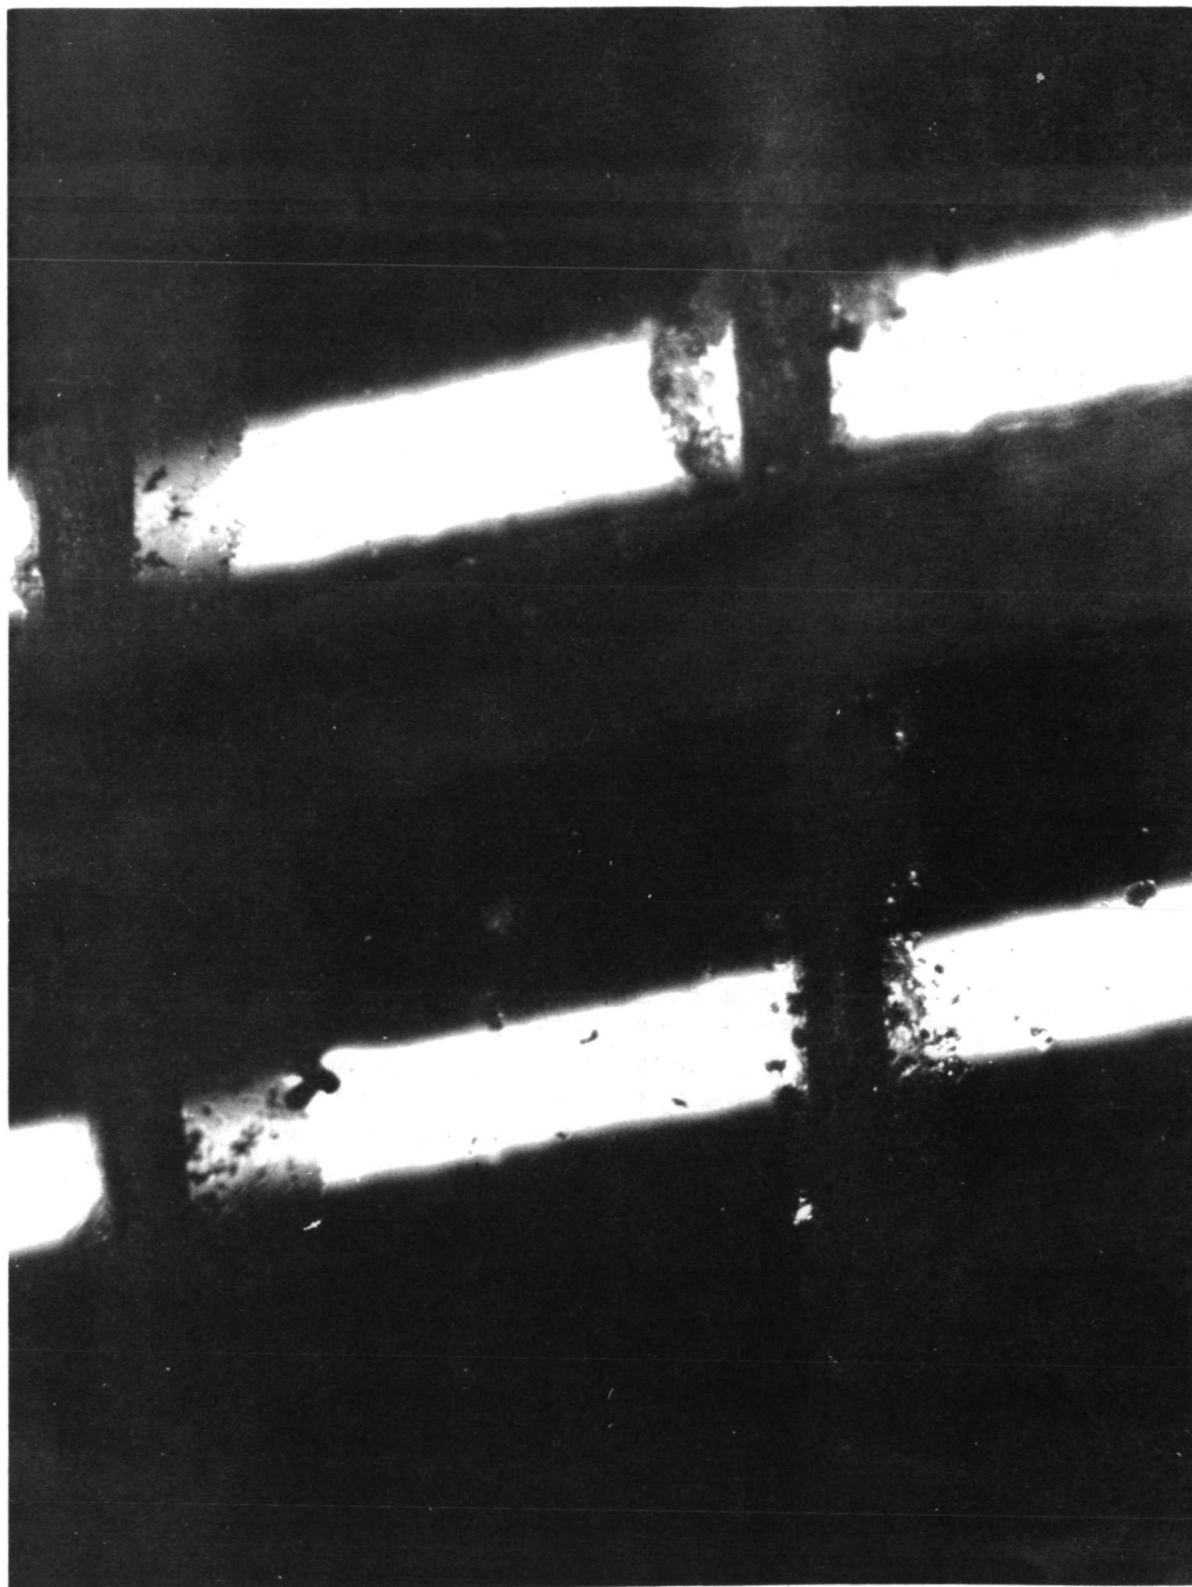
A summary of only those resistors injected with plating solution and exposed to humidity is given in table 8. Figure 55 shows R109 after 56 hours at 56 percent VR.

Figure 55. Vamistor Resistor Injected with 1% Plating Solution Dried,
Run for 56 hours in 100% Relative Humidity at 56% VR,
60 Hz ac

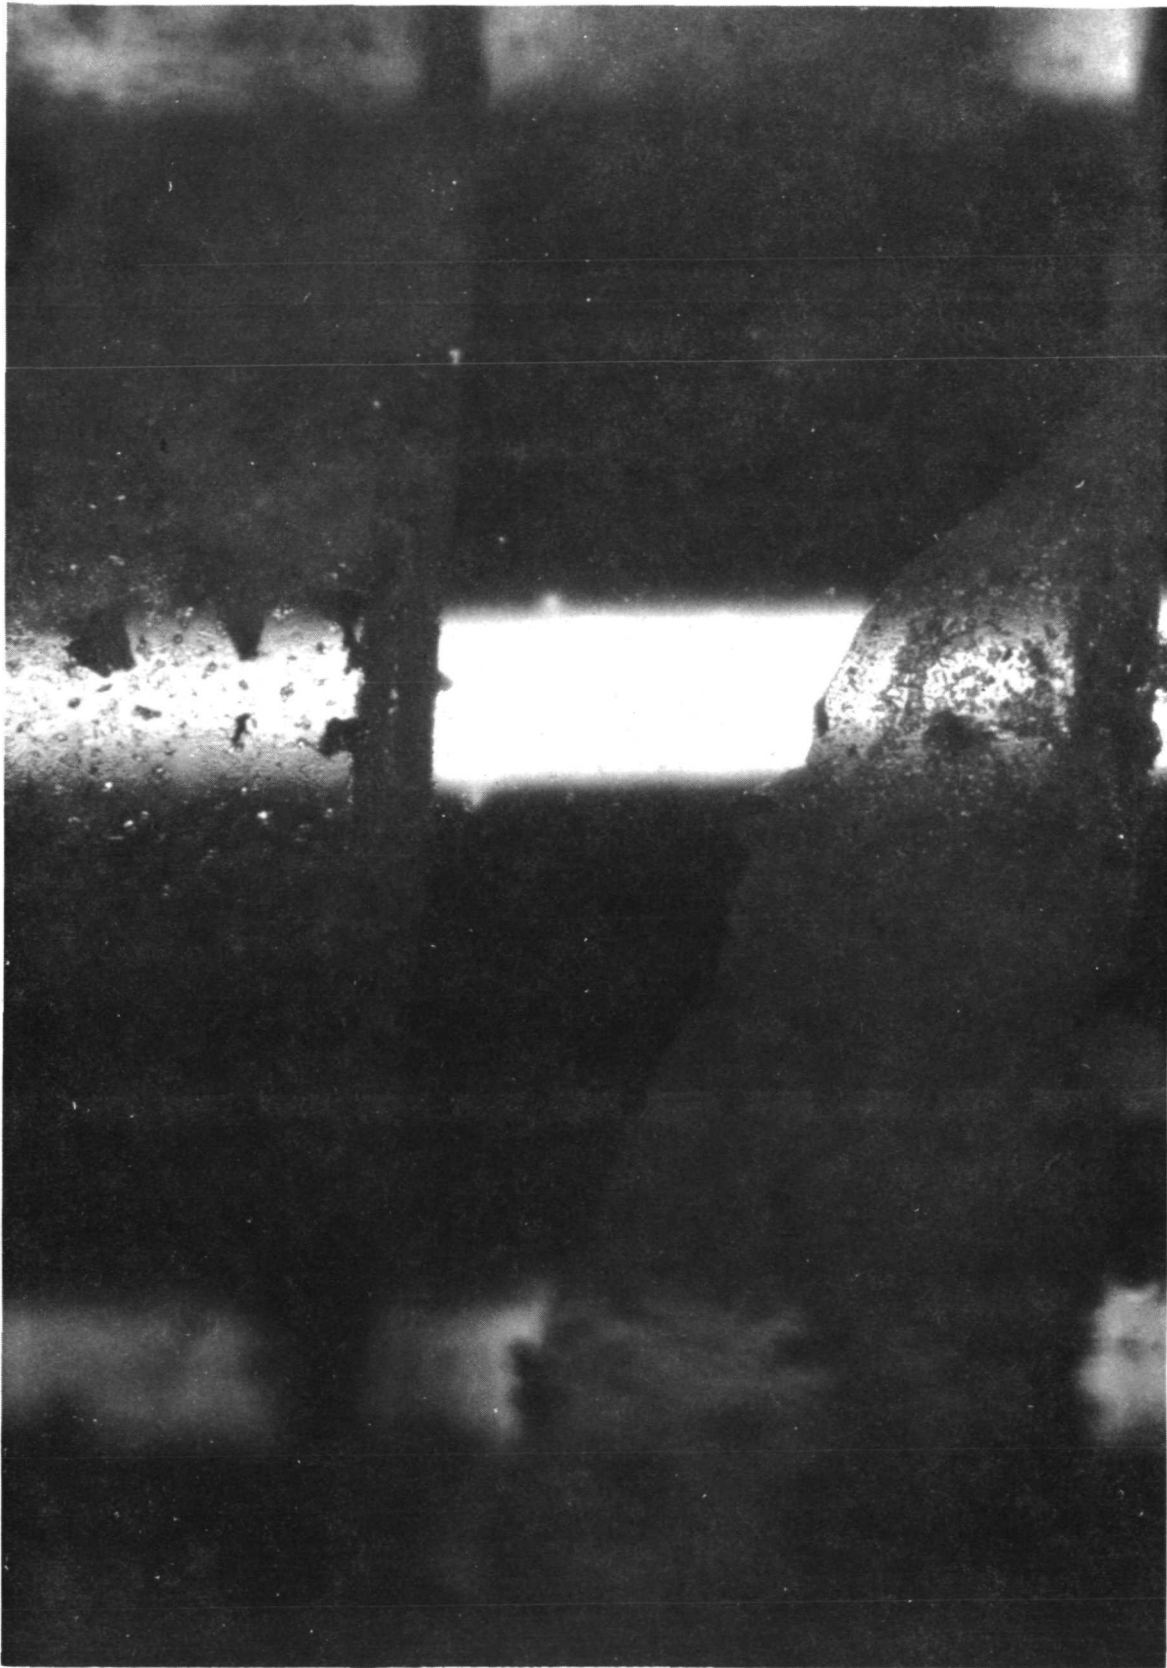
received (controls). All resistors were placed in a test chamber with a 100 percent relative humidity environment and a pulsating dc voltage was applied. The voltage was 7 volts with a 400 microsecond pulse width and a 2,000 pulse/sec repetition rate. The test was run for 476 hours. The 16.8 K ohm resistor had increased by 2.14 percent, and the 5.5 ohm resistor had increased by 441 percent at the end of one hour and were removed from the test. The 6.5 K ohm resistor remained on test for the full 476 hours and at the end of the test had increased by 6.14 percent. None of the four control resistors had shown any change. Pulsating dc voltage appears to be almost as damaging as straight dc under the same environmental conditions. Figure 57 shows R923, which changed by 441 percent after 1 hour on pulsating dc.

Figure 57. Resistor 923 0.75% Plating Solution Injected, Dried, Run at 100% Relative Humidity, on Pulsating dc for 1 hour. Total Change, 441%

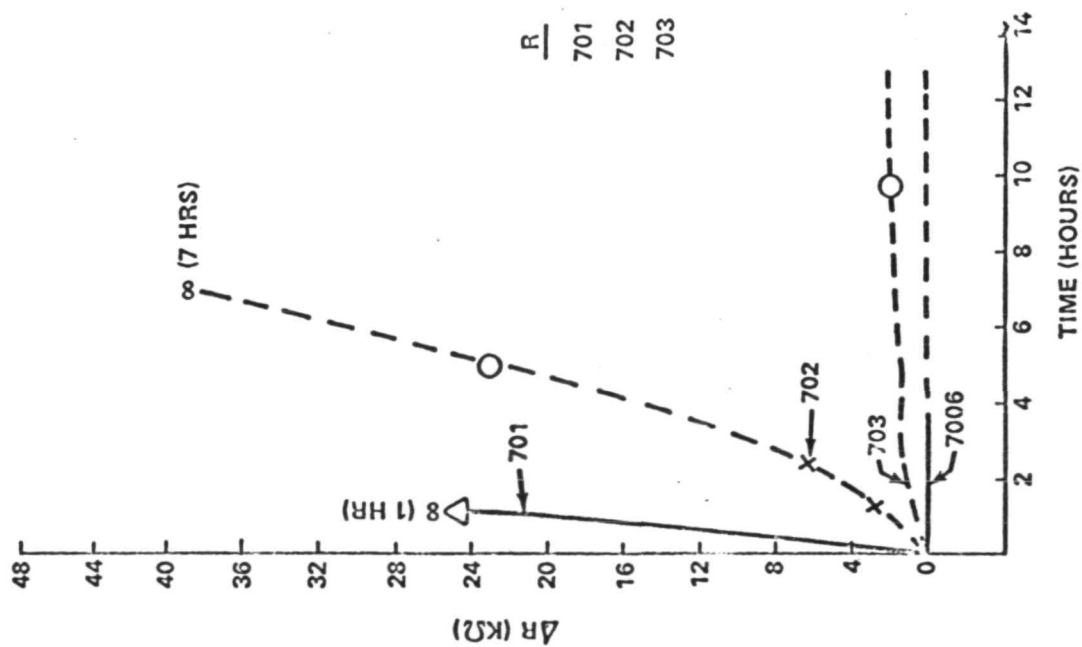
The applied voltage was 72 vdc (20 percent VR). A fourth resistor was tested as a control (no plating solution added). The results of this test are shown in figure 58. As can be seen, there was a vast difference in the drift (resistance change) of these supposedly "identical" resistors tested under the same conditions. The resistors were then sectioned and the internal configuration of each was analyzed. The data obtained are also given in figure 58. As can be seen, voltage gradient (Vg) does not correlate to resistance change but when the voltage gradient is divided by the conductor width (CW), correlation with the drift data results. This is not surprising since, if the voltage gradient (driving force for the electrochemical process) is the same, the percentage change in resistance will be proportional to the width of the conductor. If the conductor width is small a larger change will occur, in the same time period, than if it is larger. Figure 59 is a plot of Vg/CW versus resistance value for one-eighth watt Vamistor resistors. It can be seen that, as the resistor value increase, so does Vg/CW . It is important to note that the 500 K ohm resistors can have by far the largest value of Vg/CW ; also, they have the smallest film thickness. Based on this, it would seem that these resistors would be more susceptible to the damage mechanism than the other resistor sizes, all other conditions being the same.

Figure 58. Voltage Gradient Versus ΔR Tests On 511 K Resistors
